Little Penguin adoption of under-road culverts, Bruny Island 2017/18

Report to Department of State Growth, March 2018.
Eric J Woehler, Peter Vertigan and Regi Broeren, BirdLife Tasmania

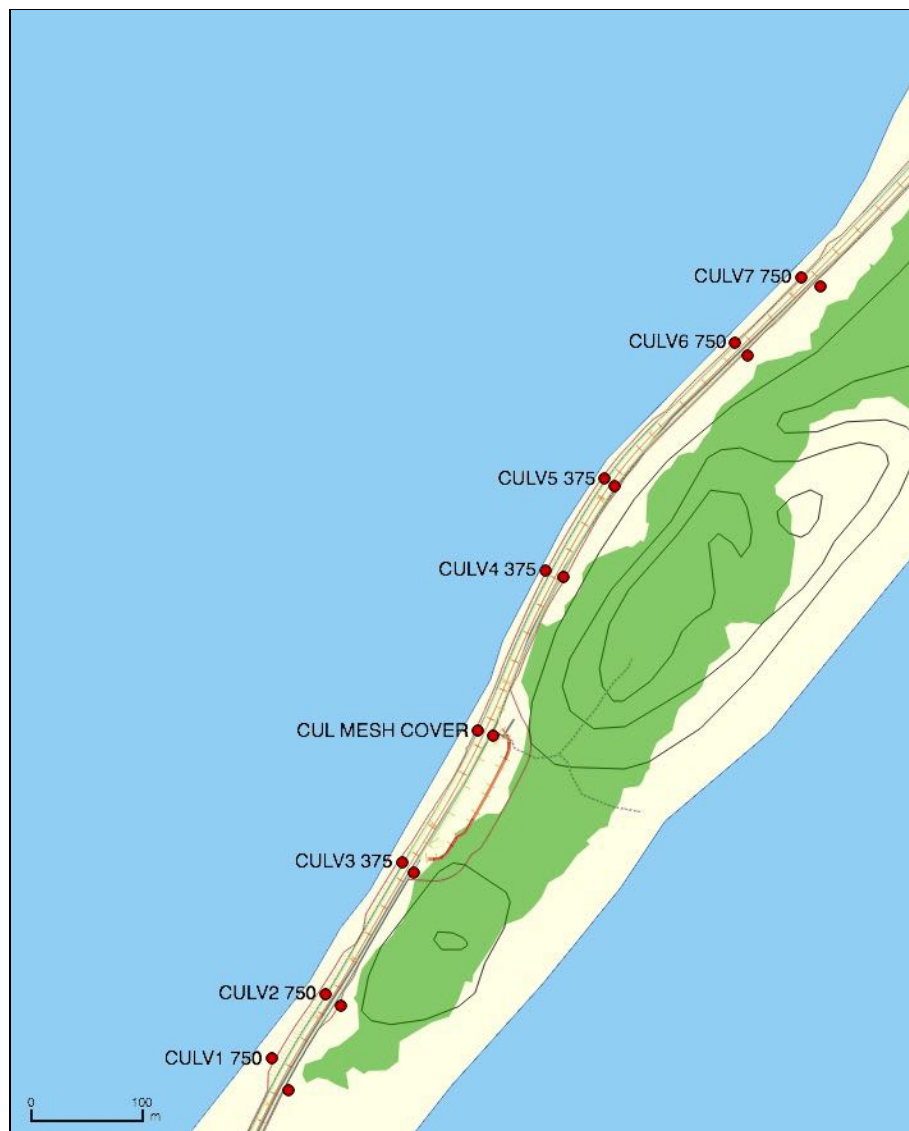
Figure 1. Map showing the Bruny Island Neck colony (green polygon), the Bruny Island Main Road and car park (lower centre), the locations of the eastern (colony) and western (d'Entrecasteaux Channel) entrances of Culverts 1 to 7 (south to north) and surface contours (10m increments). The numbers for each culvert denote their internal diameter (eg CULV 1 750: Culvert 1 has 750mm diameter); contour interval is 10m and scale bar shows 100m. Note it is believed that GPS noise is responsible for the wayward position data for the colony entrance to Culvert 1.

Figure 1 shows the location of the Neck colony, the Bruny Island Main Road and the locations of the culverts. The culverts were numbered 1 (Southernmost) to 7 (Northernmost), and excluded the one car park culvert whose ends were blocked with mesh.

Bird Life Tasmania monitoring commenced on Monday 16 October 2017 for two nights. This involved two or three observers on site along the Bruny Island Main Road between 8:00pm and 11:00pm (AEDST), recording all penguins and Short-tailed Shearwater *Ardenna tenuirostris* observations and vocalisations at the Neck colony and on the Bruny Island Main Road itself. Observers alternated between sitting close to culverts to record penguins and walking back and forth between Culverts 1 to 7, Figure 1.

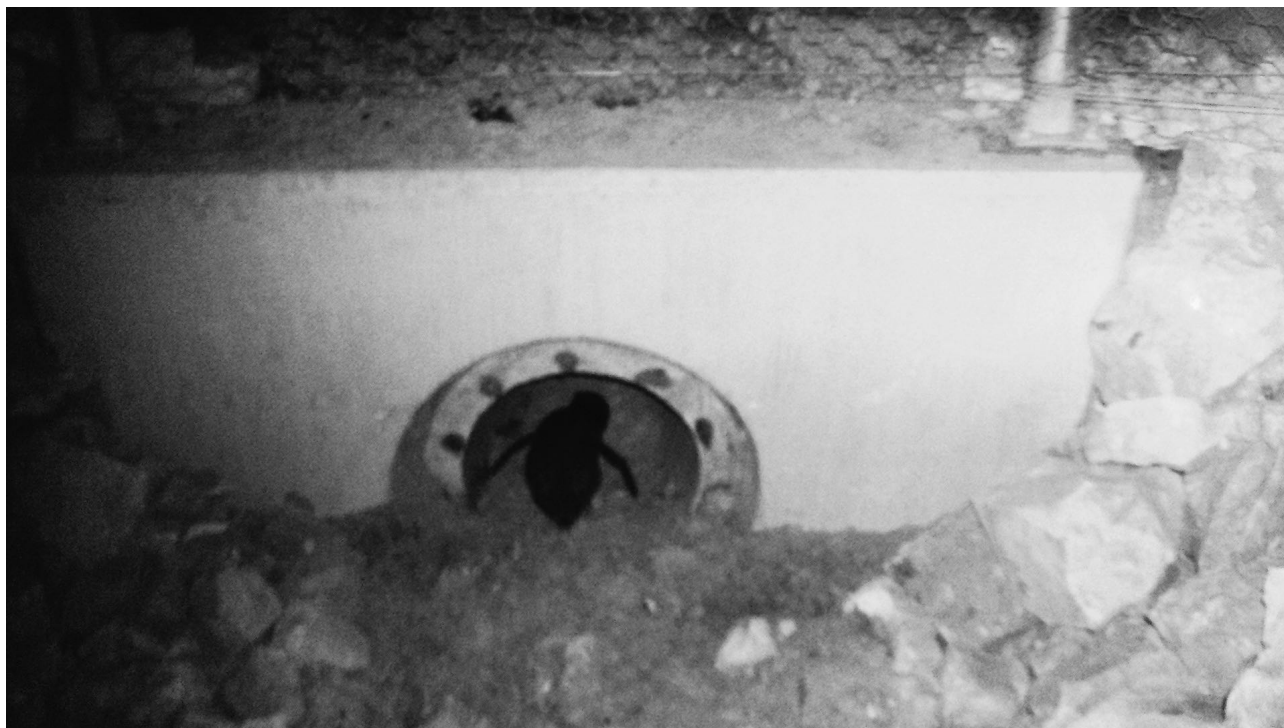
Figure 2. Photograph showing Little Penguin in Culvert 3 on 26 October 2017. Photograph ©2017 BirdLife Tasmania (image DSC02092.jpg).

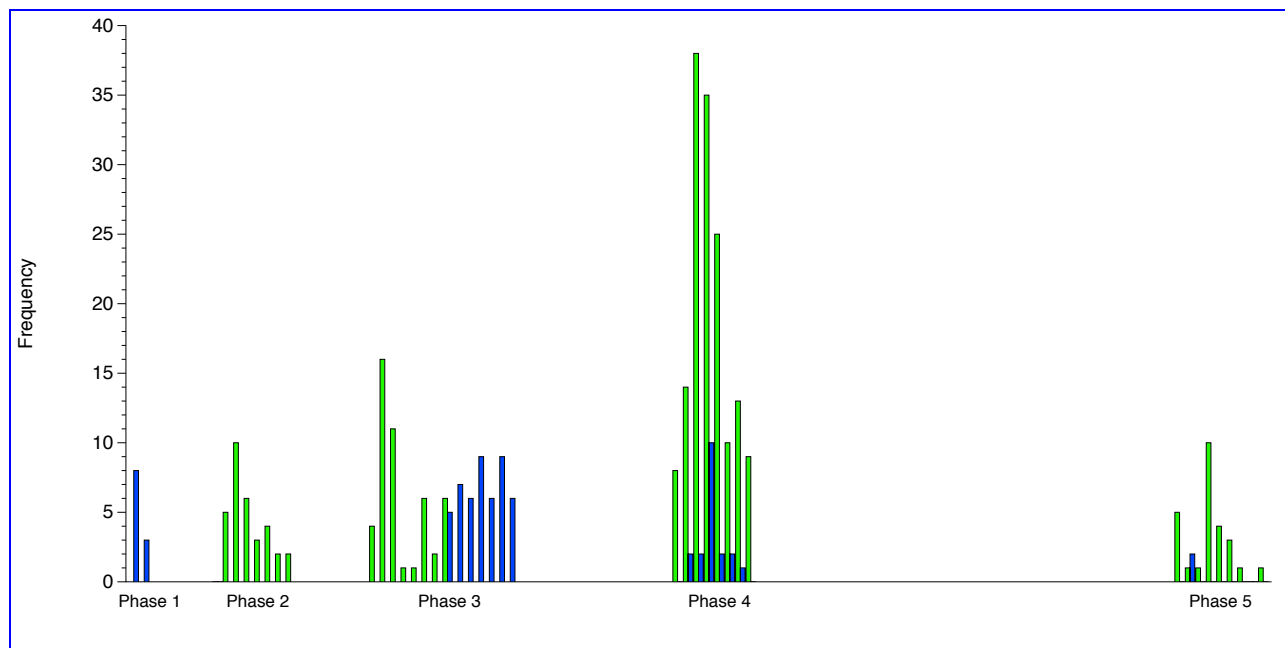
Figure 3. Graph showing the frequencies of Little Penguins photographed at the culverts (green bars) and along the roadside fence lines (blue bars), Bruny I Neck colony 2017/18 (see Table 1 for dates of monitoring phases and Table 2 for raw nightly data).

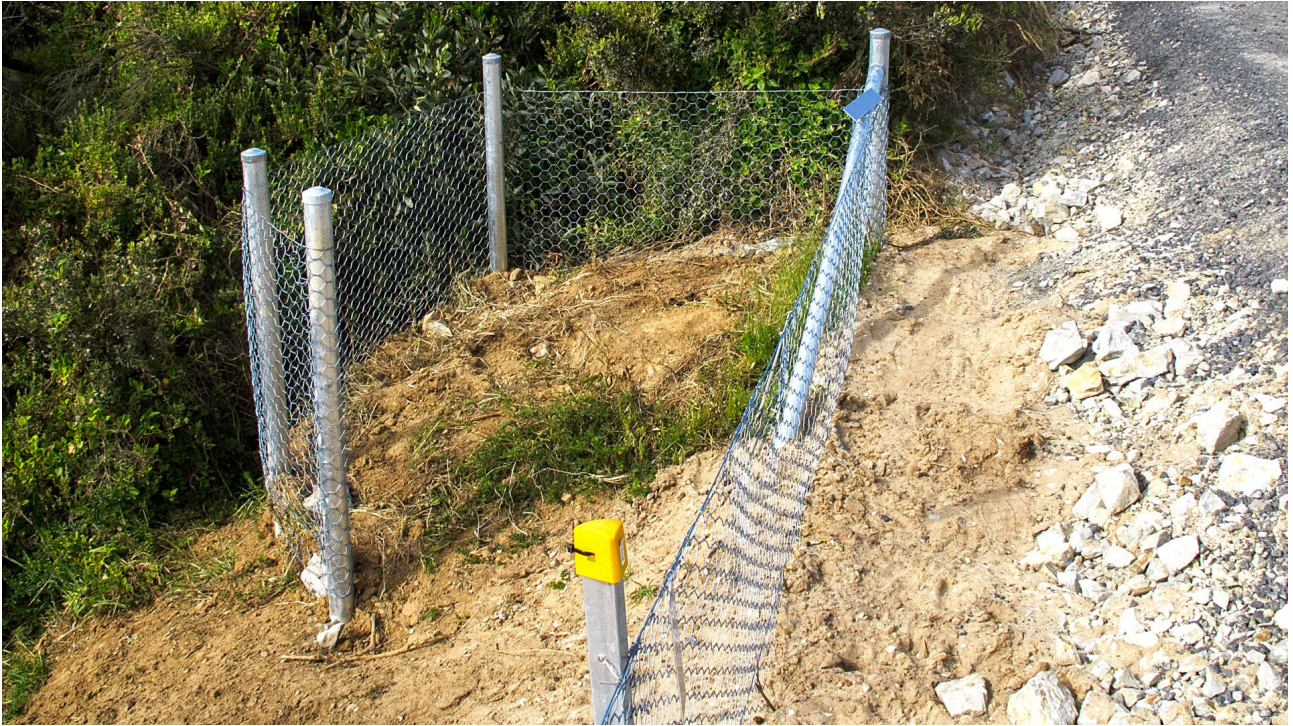
Figure 4. Photograph showing the square ‘return’ that was added to the ends of the fences to guide the penguins through 180° back towards the culvert entrances within the fencing extent. Photograph ©2018 Peter Vertigan.

- a square 'return' was added to the ends of the fences that guided the penguins through 180° back towards the culvert entrances within the fencing extent (Figure 4),

Minor modifications to the guides leading to the culvert entrances over the riprap may be required over the 2018 Winter following periods of high seas. It is not expected that further modifications are required for the roadside fencing at this point beyond adding curvature to the 'returns' (Figure 4). Minor maintenance involving replacing sand in the culverts' entrances may be required if it has been washed away. Conversely, culvert entrances that are filled with vegetation or sand following poor weather will need to be cleared to ensure the culverts are usable for the penguins.

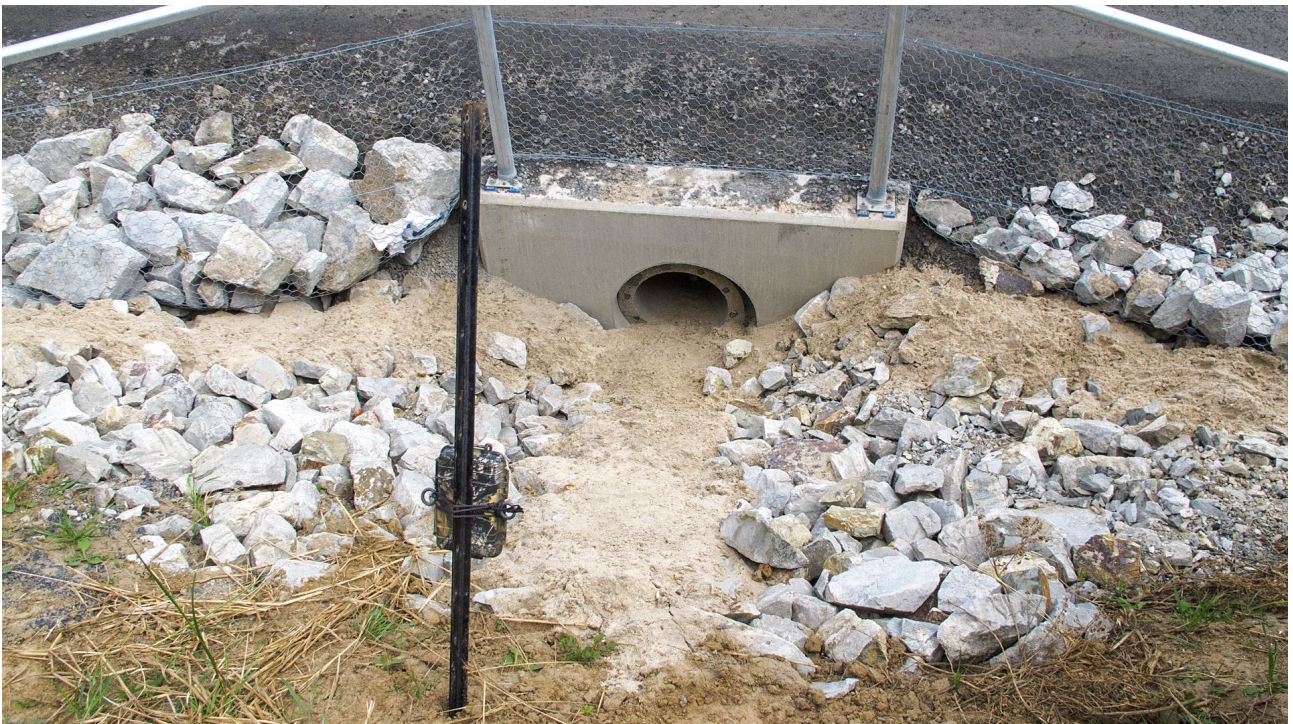
Figure 5. Photograph showing the sand and small gravel that was added to the culvert entrances as a transition from the riprap to the smooth concrete of the culverts. A camera trap is shown *in situ*. Photograph ©2018 Peter Vertigan.

- sand and small gravel was added to the culvert entrances as a transition from the riprap to the smooth concrete of the culverts (Figure 5),
- the riprap material was slightly rearranged below the culvert entrances with beach sand placed to form a pathway to direct penguins towards the culvert entrances (Figure 6),

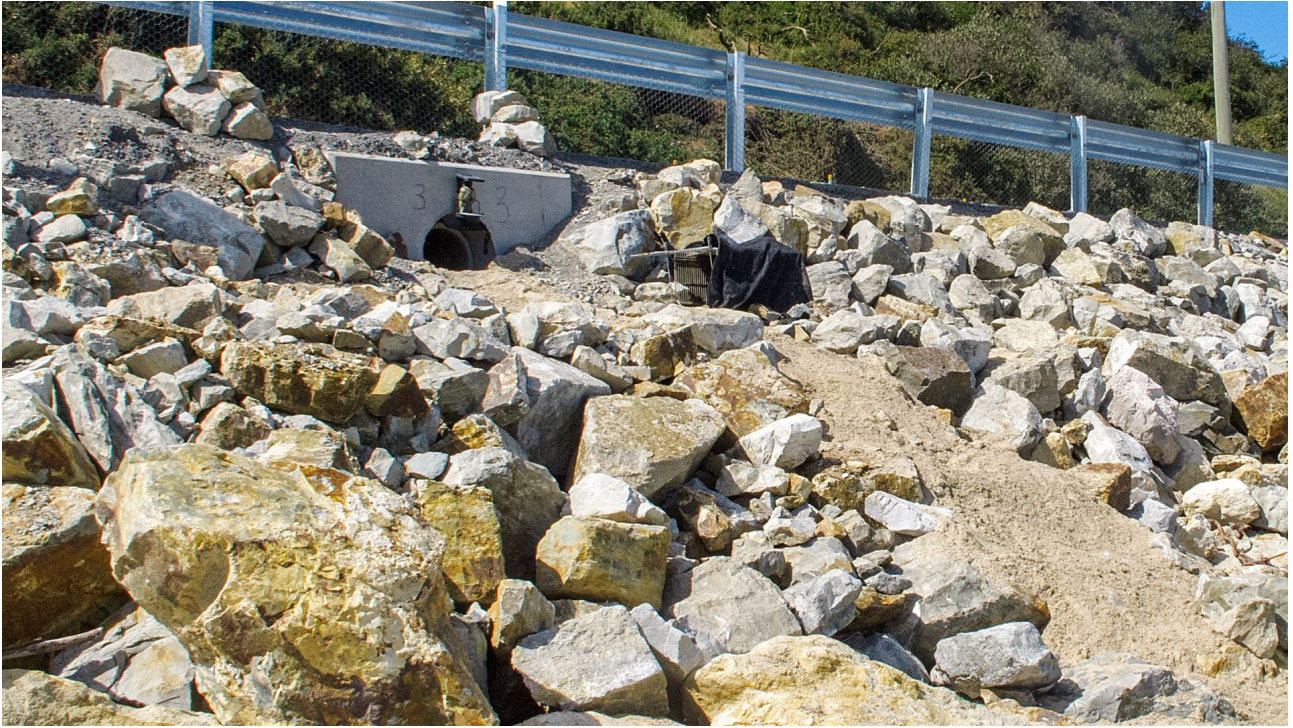
Figure 6. Photograph showing the path through the rearranged riprap material below the culvert entrances with beach sand placed to form a pathway to direct penguins towards the culvert entrances. Photograph ©2018 Peter Vertigan.

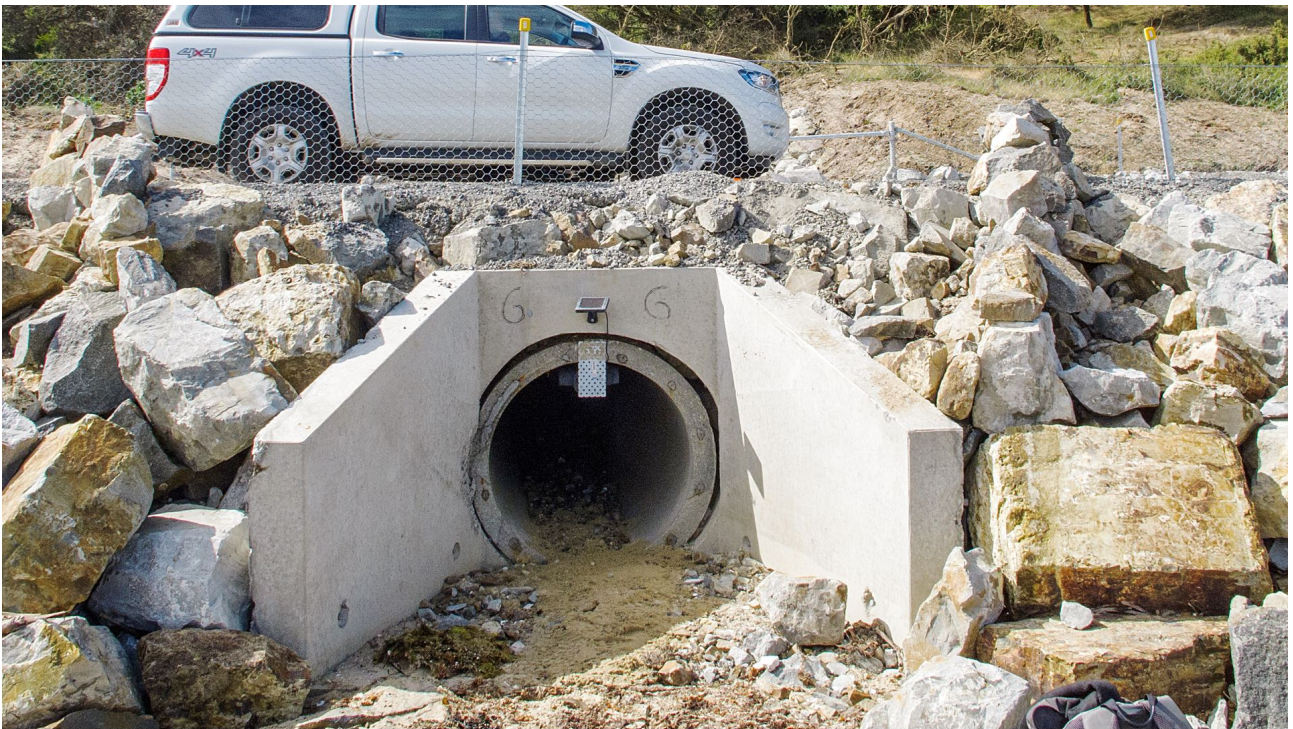
Figure 7. Photograph showing the rocky 'guides' that were constructed from the roadside fence line to the culvert entrances on the rip rap to divert penguins from the fence line to the culvert entrances on the d'Entrecasteaux Channel side of the road. Photograph ©2018 Peter Vertigan

- rocky 'guides' were constructed from the roadside fence line to the culvert entrances on the rip rap to divert penguins from the fence line to the culvert entrances on the d'Entrecasteaux Channel side of the road (culverts 3, 4, 5, 6 and 7) (Figure 7), and

- all rock 'guides' were subsequently replaced with posts and fencing material identical to that used along the roadside; this was done by PWS/pakana services.
