Kingborough Council Shoreline Monitoring Program

Prepared by Matt Dell and Chris Sharples

2014

Prepared by Matthew Dell and Chris Sharples, Blue Wren Group, Department of Geography and Environmental Studies, University of Tasmania, 2014.

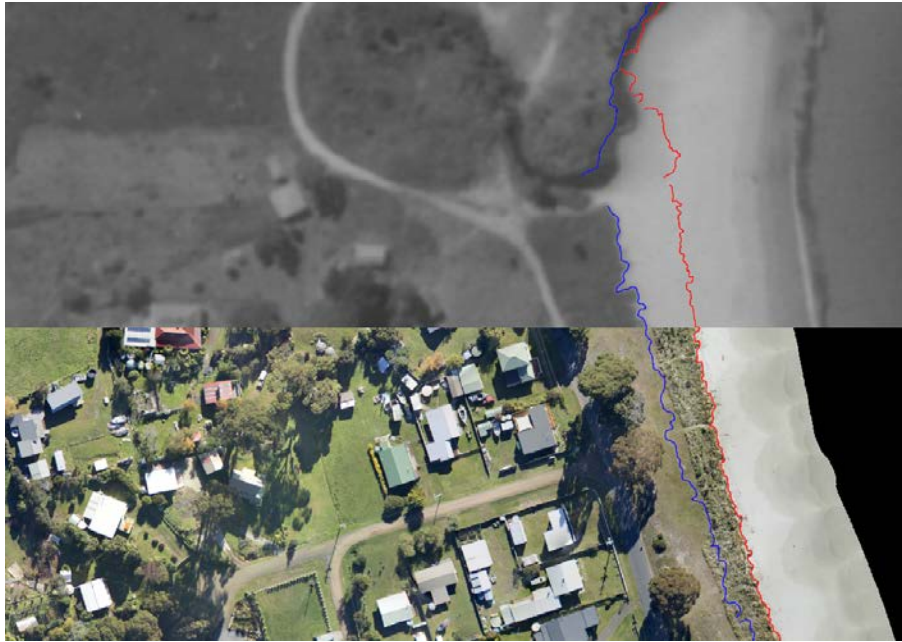
The shoreline analysis at Adventure Bay Beach shows an average seaward growth of 7 metres between the 1940's and 2013 with a maximum recession of 7 metres at the southern end of the beach associated with Bligh's Creek and maximum shoreline growth of 21.5m recorded in the vegetation at the mouth of Captain Cook Creek (Figures 5 and 6).

Figure 5. Shoreline growth at Captain Cook Creek at north Adventure Bay.

It is recommended that the Adventure Bay study area be continually monitored as its low lying nature makes it particularly vulnerable to erosion and inundation during storm events potentially resulting in rapid changes in shoreline position.

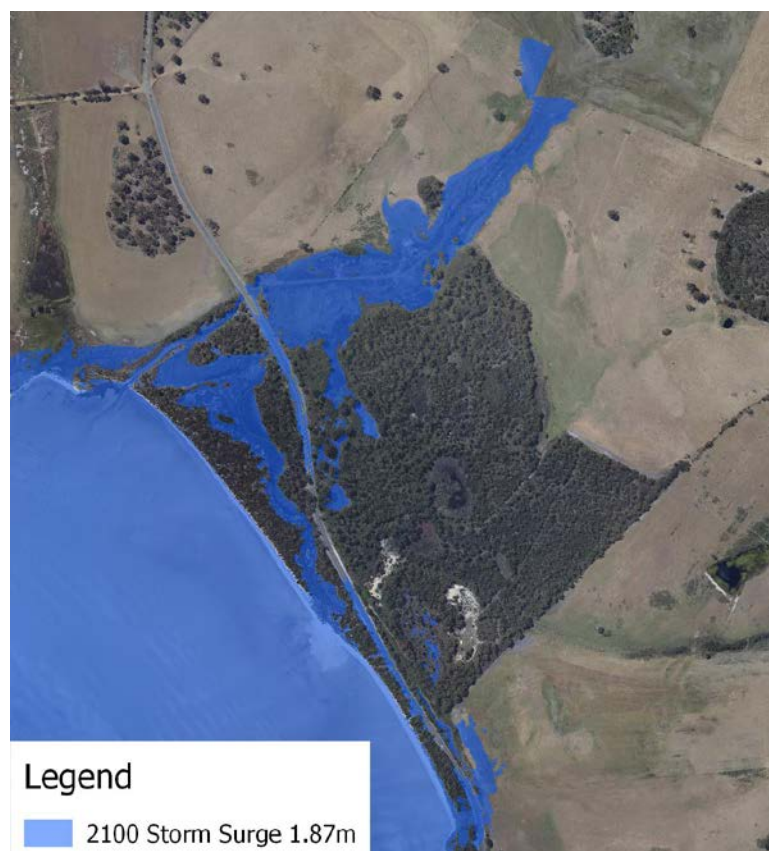
Preliminary modelling of inundation from the first pass digital elevation model shows parts of the road and low lying saltmarsh complexes will become inundated at the north end of Great Bay based on an indicative 2100 storm surge event of 1.87 metres above the current mean average sea level (McInness *et al* 2012)(Figure 7).

Figure 7. Potential inundation during a 2100 storm surge event.

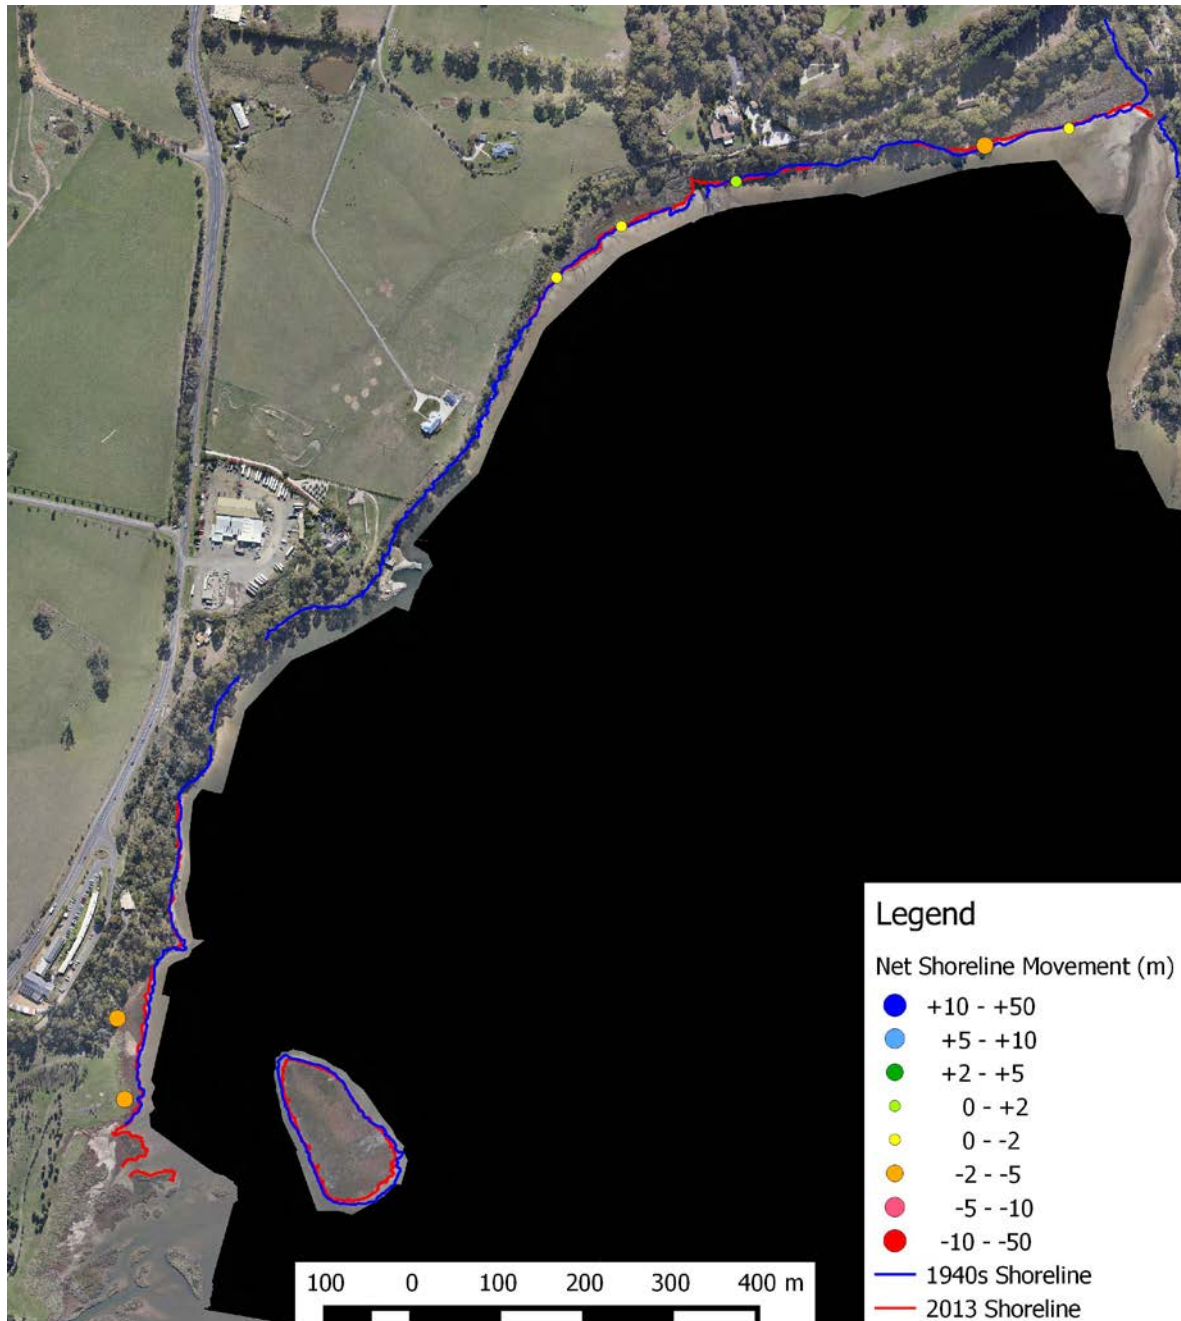
This shoreline showed a generally recessive shoreline response with a maximum recession of up to six metres observed in several places (Figure 11). There were a few small discrete pockets of observed shoreline growth associated with small permanent watercourses. It should also be noted that the observed shoreline position measured around the mouth of the North West Bay River will be highly variable due to the active water flow and associated sediment transport. The small island offshore to the north east of the North West Bay River shows a significant and consistent recession signal averaging around five metres.

Figure 11. Howden to North West Bay River shoreline movement

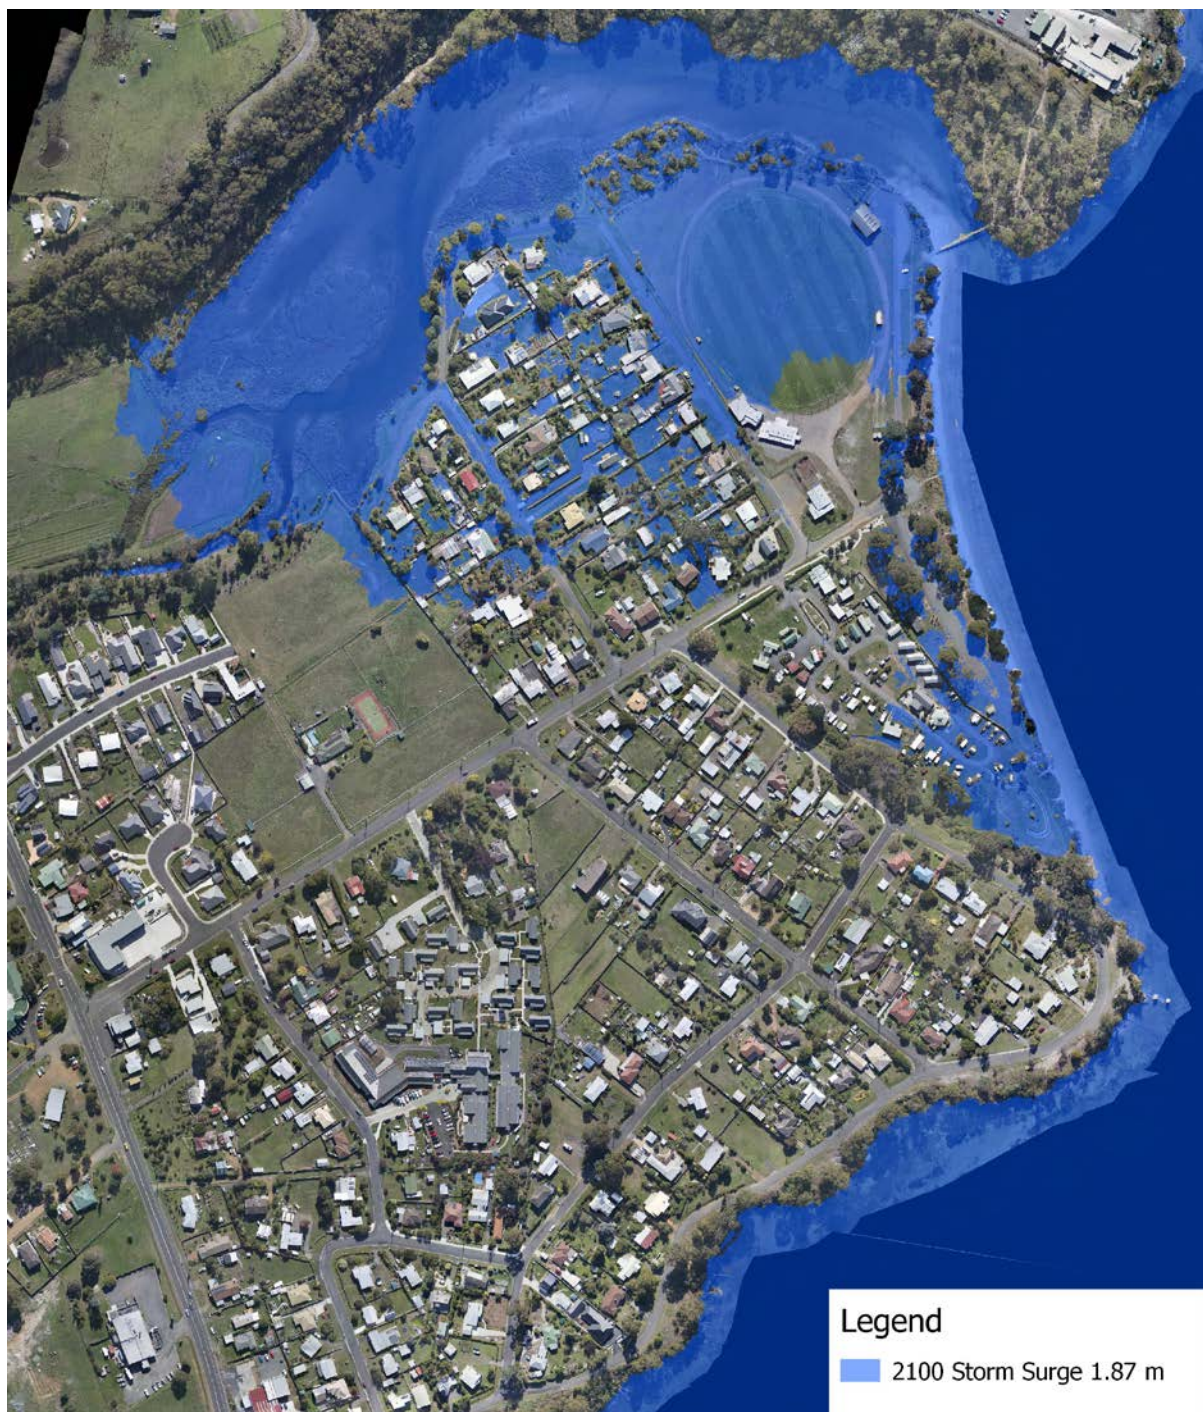
The low lying and poorly consolidated nature of the landforms at Snug combined with the proximity of the Snug River make it particularly susceptible to inundation during large storm surge events. Figure 18 shows the effect of a storm surge event based on the predicted sea level at 2100.

Figure 18. Predicted Storm surge extent at Snug based on 2100 IPCC Sea Level Predictions

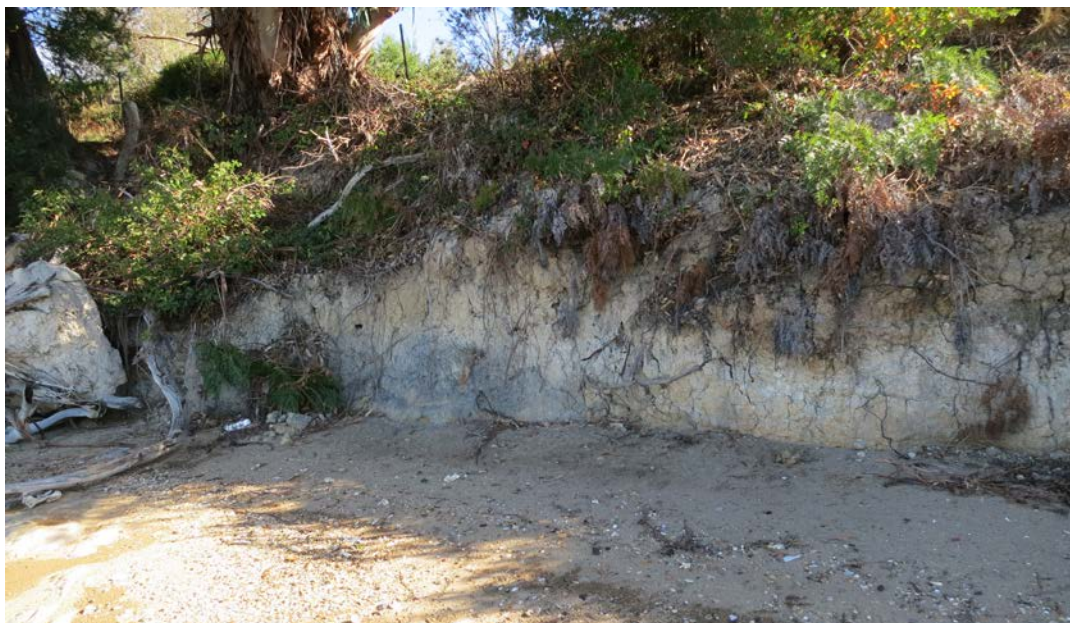
However useful data was extracted manually from the digitised shorelines. The northern half of the bay showed a variable shoreline response with a shoreline recession of up to 3 metres recorded on the low colluvial shorelines between Schemers Creek and Perry Road. These low lying shorelines continue to exhibit small active erosion scarps (Figures 20 and 21).

Figure 20. Small erosion scarp in poorly consolidated sediments at Peppermint Bay

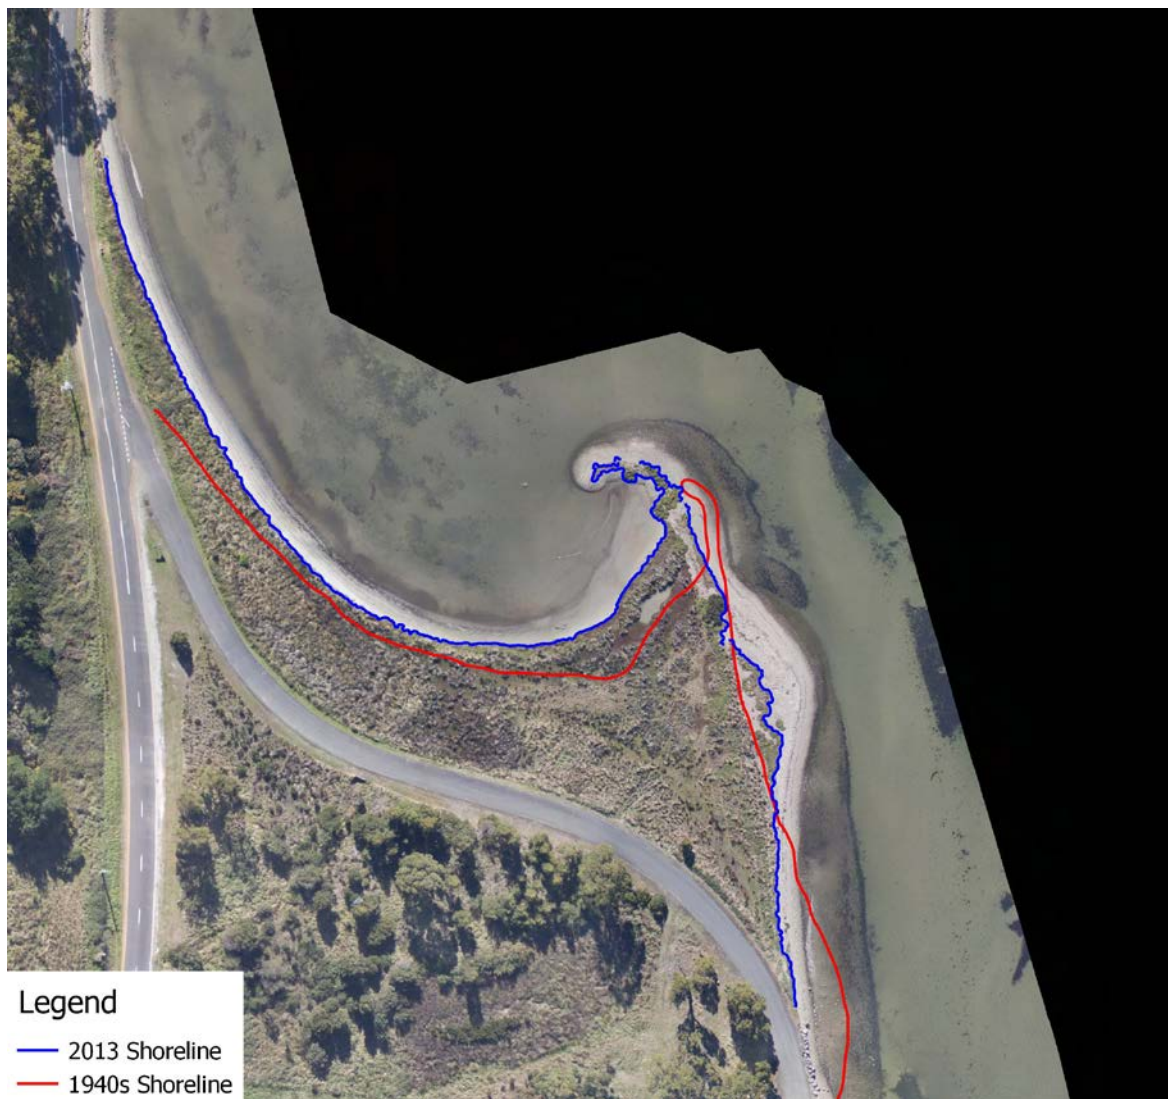
At Three Hut Point the low lying Quaternary beach sediments have moved seaward and northwards between 1.8 and 12 metres since the 1940's. The east facing beach is variable in its response having receded around 10 metres close to where the road meets the coast and the spit shifting north-west over 12 metres from its 1940's position (Figure 22).

Figure 22. Shoreline movement at Three Hut Point

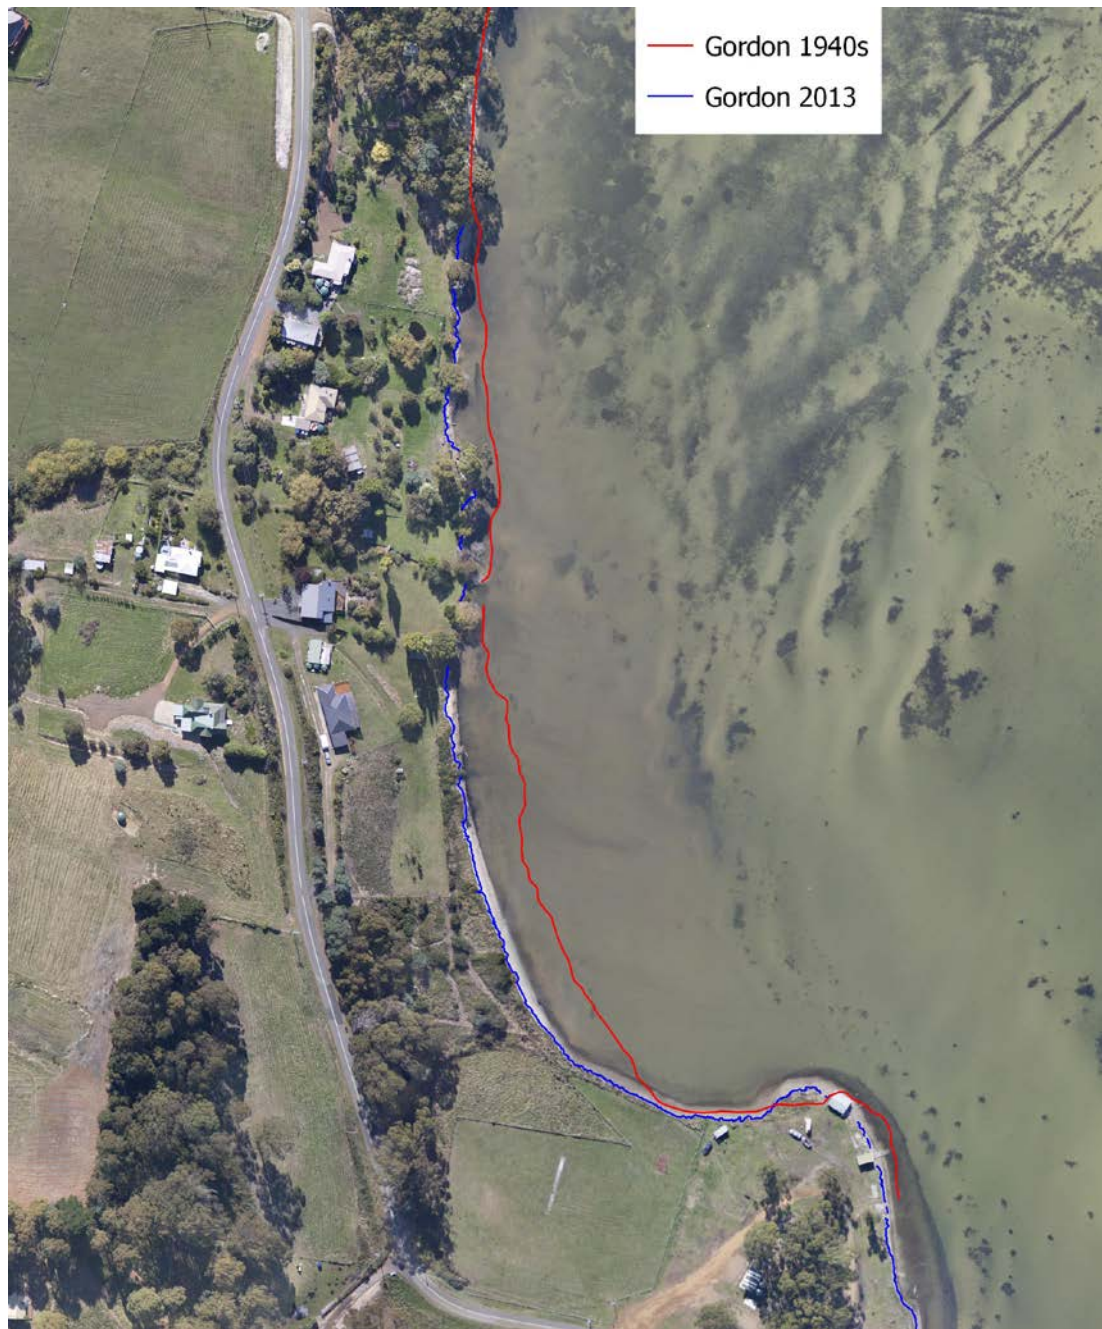
At Gordon the low lying coastal Quaternary sediments show a similar behaviour (Figure 23). The small north facing beach adjacent to the old sports oval has receded shoreward around 2 metres, while the more east facing low angle sandy shore extending northwards to Rookwood Creek has experienced considerable erosion in excess of 25 metres in some places. North of Rookwood Creek the shore is backed by a rapidly receding Tertiary sediment scarp which has receded between 7 and 14 metres.

Figure 23. Shoreline movement at Gordon

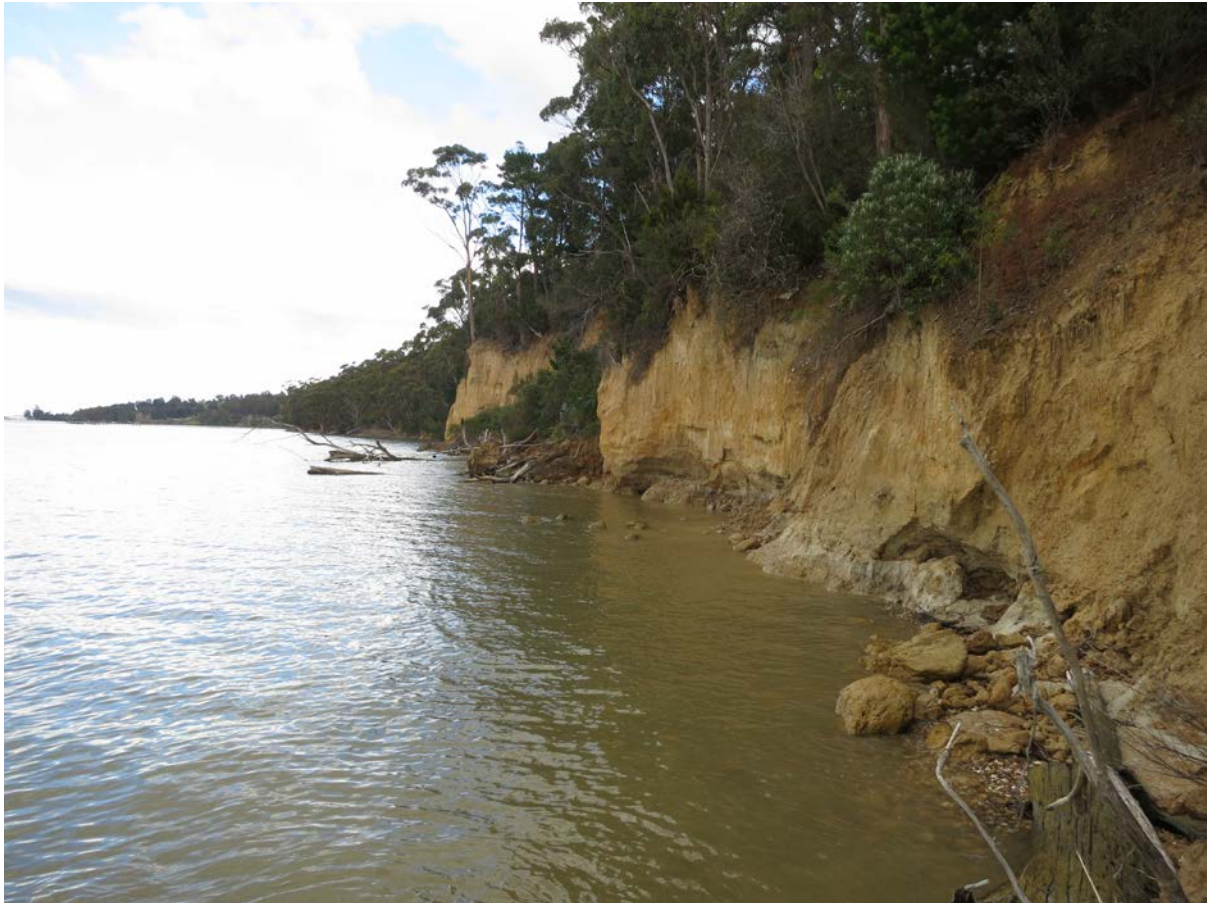
Much of the shoreline to the north and south of McKay Rivulet is not visible from the air due to the collapse of numerous large trees along the eroding shoreline. The scarp is up to 8 metres high in places and the poorly consolidated sediments are actively eroding (Figure 24). The height and nature of the scarp recession necessitates some urgent and ongoing on-ground monitoring.

Figure 24. Eroding Tertiary sediments close to McKay Rivulet

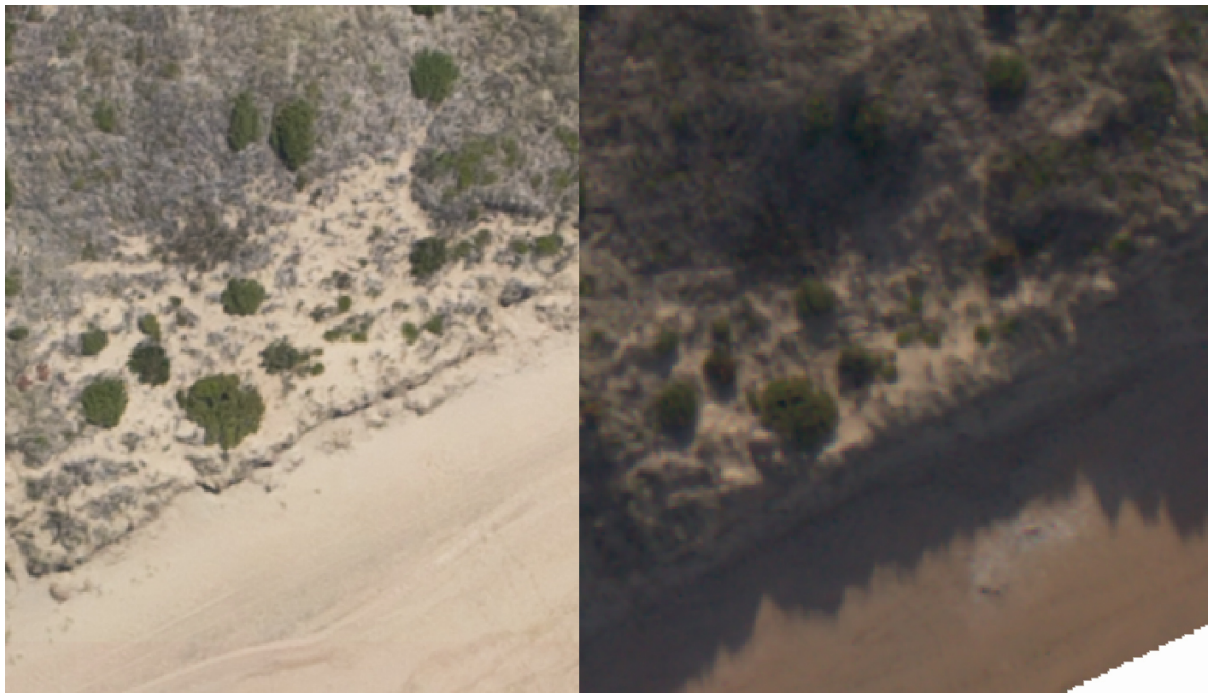
Figure 25 – Summer 2013 (left image) and Winter 2012 (right image) comparison of steep section of Beach.

Where possible repeated annual aerial surveying should occur during summer months where it is possible to eliminate the shadows cast by the dune scarps or dune vegetation. This shadowing can affect the clarity of the aerial photography which in turn affects the clarity of the vegetation line and accuracy of the derived three dimensional models. For rapid response flights before or after major events it is recommended that shorter flights throughout the day be used to minimise shadowing on east, west and south facing beaches.
